Case 398 : Narrative

Case Vehicle (A): 2000 Ford	Vehicle (B): 2002 Ford
Type: Taurus SE, 4-door sedan	Type: Mustang GT, 2-door coupe
Driver: 19-year-old male	Driver: 44-year-old male
CDC: 12-FREW-3, 00-TDDO-3	CDC: 12-FREE-6

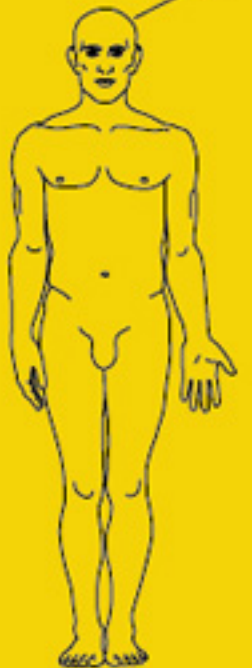
Loss of consciousness for an
unspecified length of time,
GCS (Glasgow Coma Score) was
14 on admission (2)

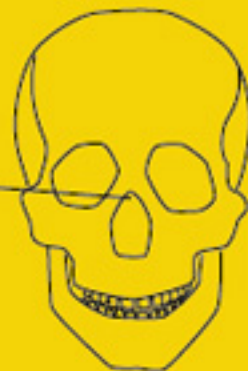
Fracture, nose (1)

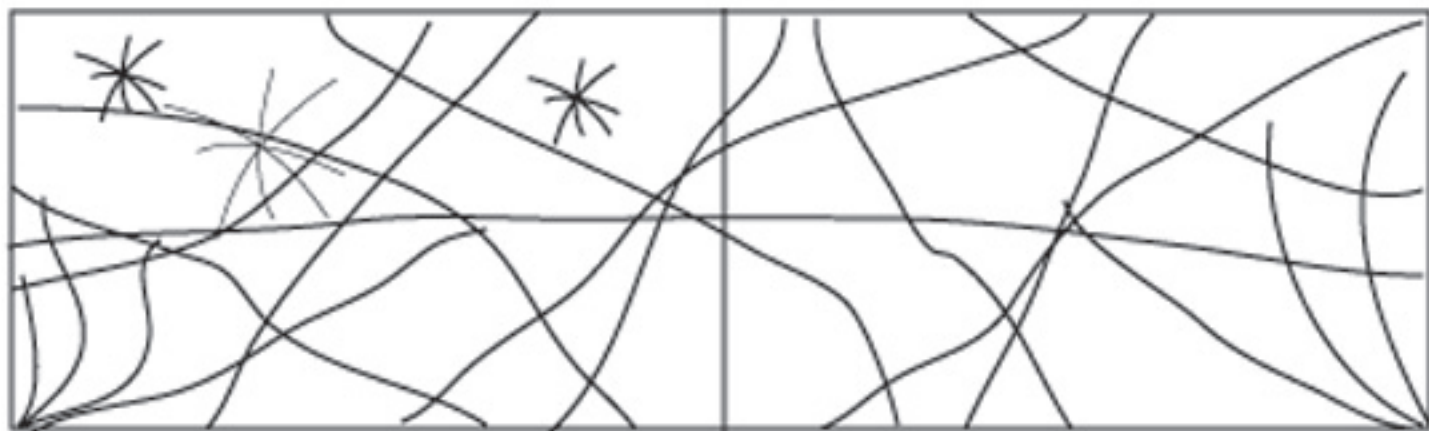
Windshield cracked through out due to roof crush and deformation of both A-pillars

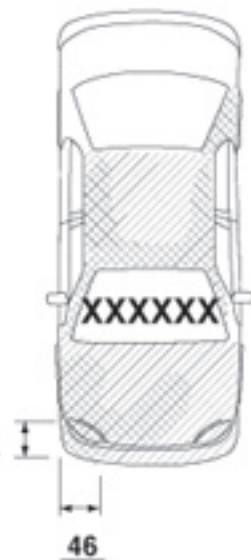
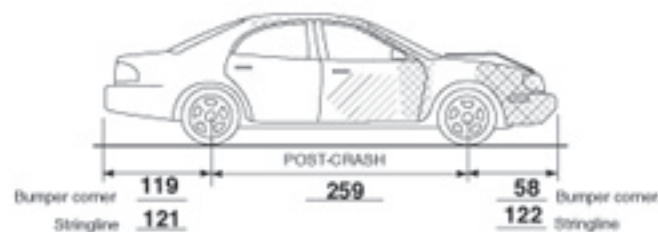
Max. crush to right-front bumper corner — 50

Width of direct damage to front

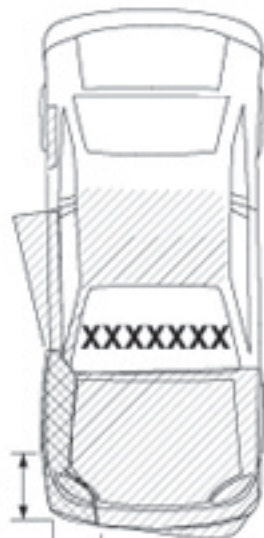
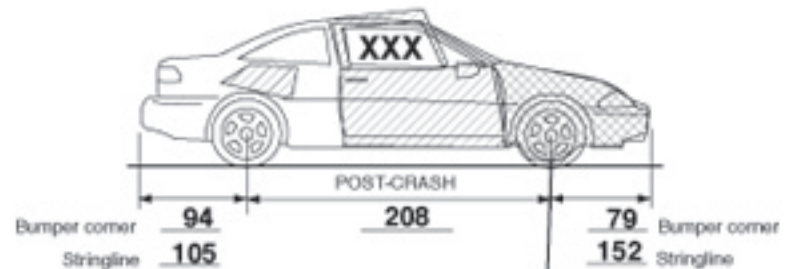
Max. crush to right-front bumper corner

63

Width of direct damage to front
